TECHNICAL REPORT REMR-CO-3

CASE HISTORIES OF CORPS BREAKWATER
AND JETTY STRUCTURES

Report 5

NORTH ATLANTIC DIVISION

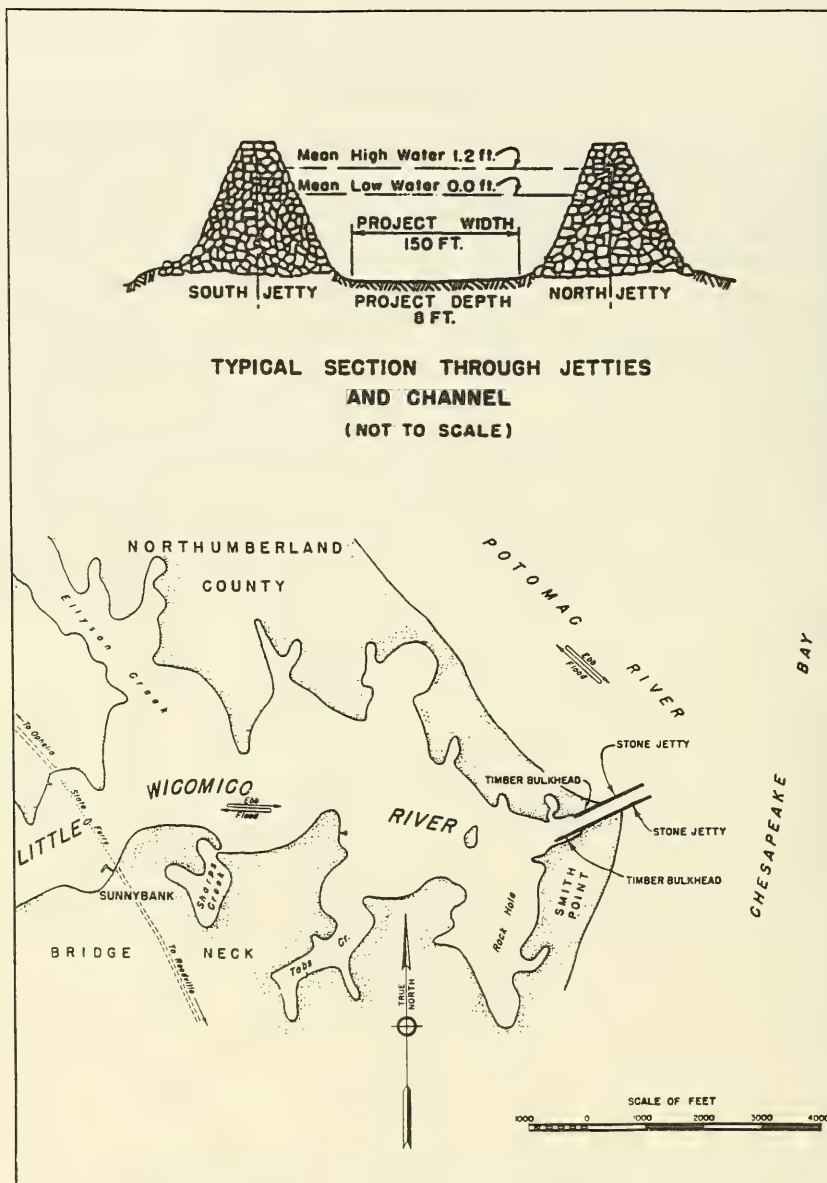
Figure 67. Little Wicomico River, Virginia

<u>Date(s)</u>	<u>Construction and Rehabilitation History</u>
1937	Two stone jetties were constructed to lengths of 1,000 and 1,300 ft north and south, respectively (Figure 67). Timber pile jetties were also placed at the landward ends of the stone jetties. Lengths of the timber piles were 357 ft north and 650 ft south.
1970	The north timber pile jetty was repaired at a cost of \$51,822.
1981	Survey of the jetties indicated the seaward 300 ft of each jetty had crown elevations ranging from -2.0 to +6.0 ft and no semblance of a crown width.
1985	The jetties were to be rehabilitated to minimize shoaling of the federal channel. The seaward 290 ft of each jetty was to be made sand tight by placing core stone and cover stone on the outer face at a 1-V:1.5-H slope. Crown elevation was to be +4.0 ft mlw, with a crown width up to 15.0 ft along the sections with crown elevations below +4.0 ft mlw. Toe protection was to be provided by a 2.0-ft-thick by 5.0-ft-wide extension of the core stone. A double layer of 1.0-ton cover stone was to be used. It is not known if the work was done.

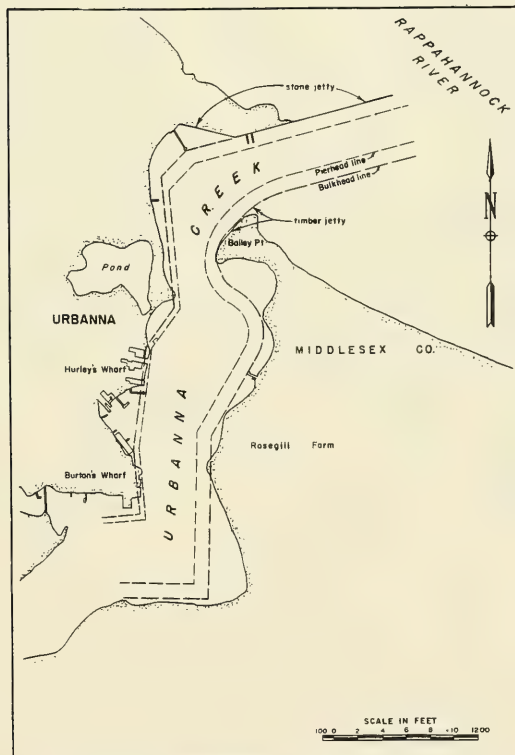
Figure 68. Urbanna Creek, Virginia

<u>Date(s)</u>	<u>Construction and Rehabilitation History</u>
1956	Two jetties were constructed for channel control. The north jetty, 1,895 ft long, was rubble mound. The 717-ft-long south jetty was built of timber (Figure 68).
1962	The north jetty was rehabilitated.
1986	No further repair or maintenance information has been found.

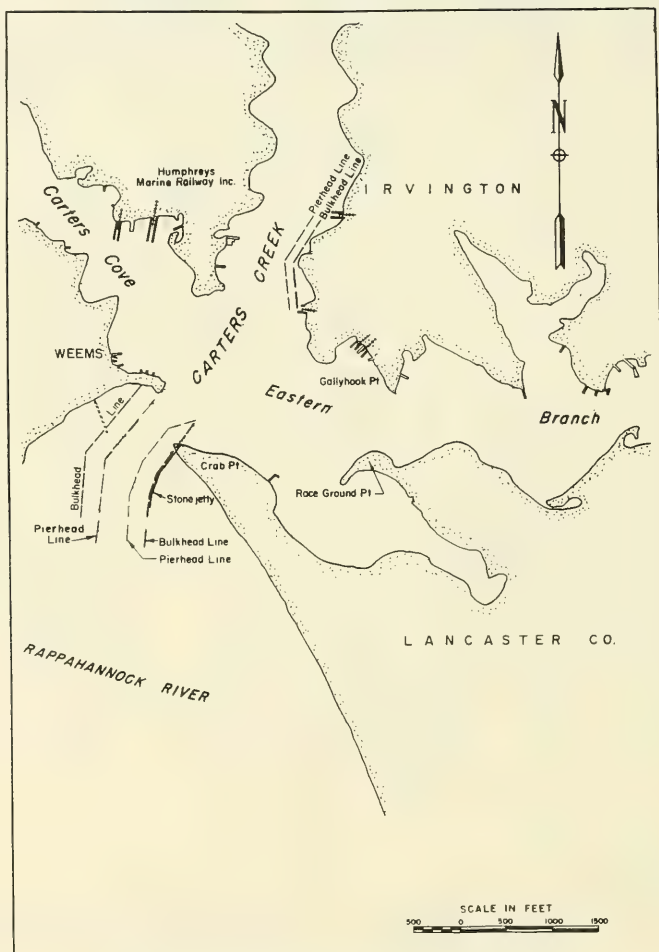
Figure 69. Carters Creek, Virginia

<u>Date(s)</u>	<u>Construction and Rehabilitation History</u>
1902-1906	A 742-ft-long rubble-mound jetty was built to provide channel control (Figure 69).
1986	No further repair or maintenance information has been found.

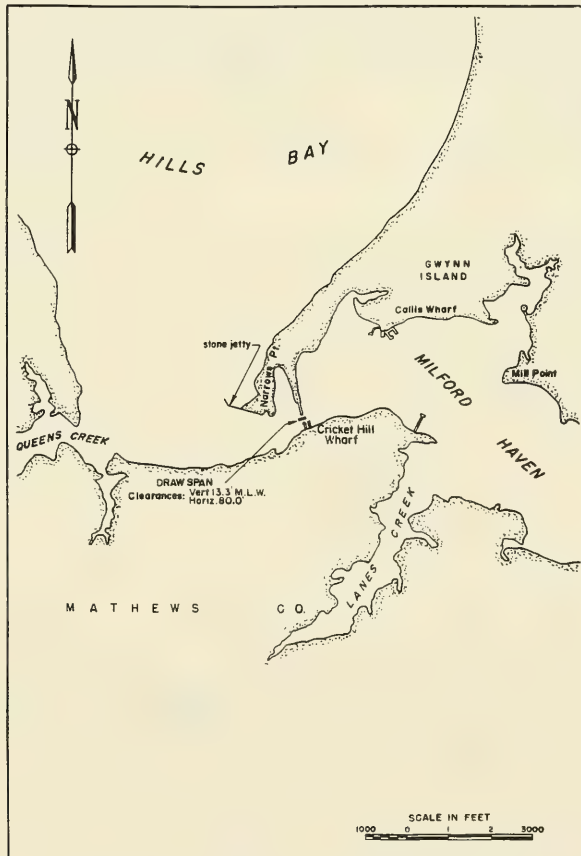
Figure 70. Milford Haven, Virginia

<u>Date(s)</u>	<u>Construction and Rehabilitation History</u>
1913	A 1,183-ft-long rubble-mound jetty was constructed to provide channel control (Figure 70).
1986	No further repair or maintenance information has been found.

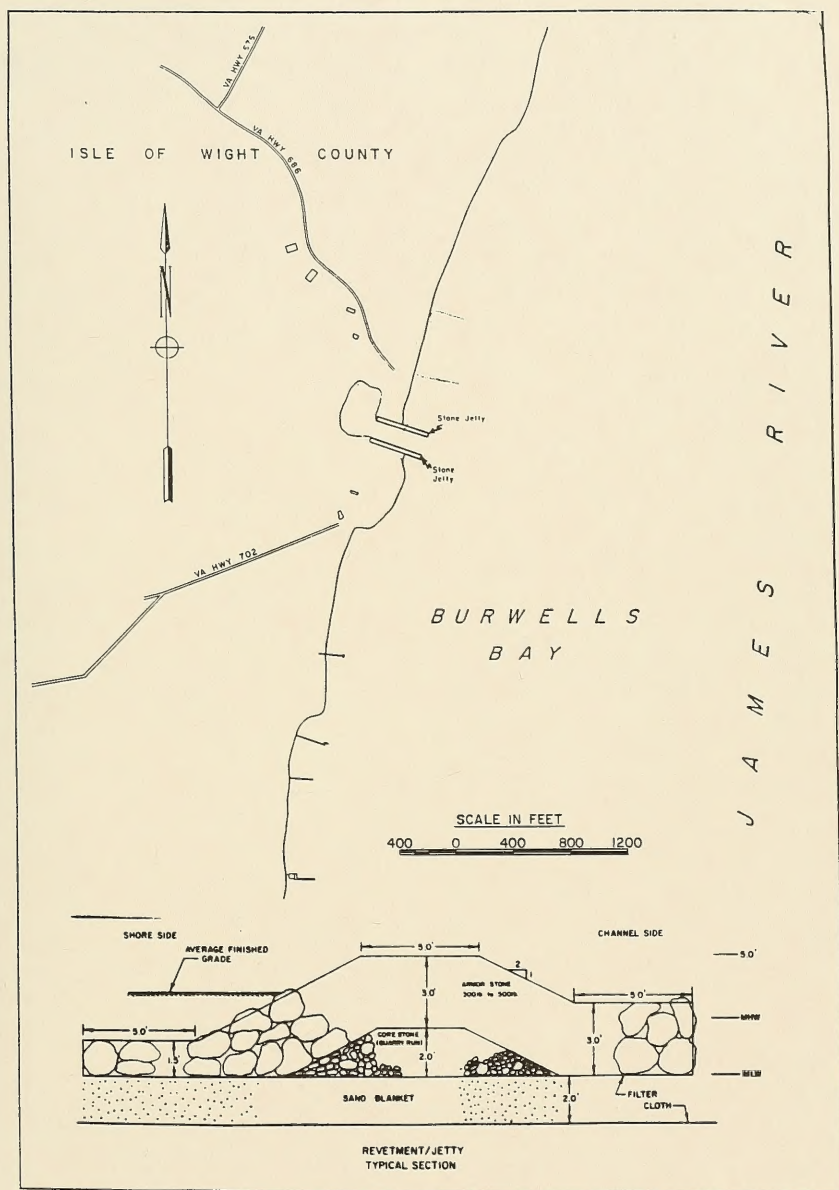
Figure 71. Tylers Beach, Virginia

<u>Date(s)</u>	<u>Construction and Rehabilitation History</u>
1981	Two parallel rubble-mound jetties were constructed to provide channel control. Both jetties were 370 ft in length and spaced 120 ft apart (Figure 71). Crest elevation was +5.0 ft mhw but allowed for 0.5 to 1.0 settlement; crown width was 5.0 ft; and side slopes were 1V:2H. One layer of armor stone, 300 to 500 lb, was placed over one layer of core stone, 3.0 to 40 lb. The jetties rested on a 2.0-ft-thick sand blanket. The sand was encased by filter fabric. A 5.0-ft-wide, 1.5-ft-thick apron and a 5.0-ft-wide, 3.0-ft-thick apron were placed on the shore and channel sides, respectively (Figure 71). A 6.0-sec, 4.1-ft design wave was used. Estimated cost of construction was \$245,000.
1986	No further repair or maintenance information has been found.
